# Zero/Six

4rd QRTR 2019

## A HISTORIC COLLABERATIVE EFFORT

by Bill Coltzer, Jr., AIA, Daniel Hodge, Lidija Bikova, Jeffrey T. Bishop, PE, Steve Singleton, and Katie McConnell

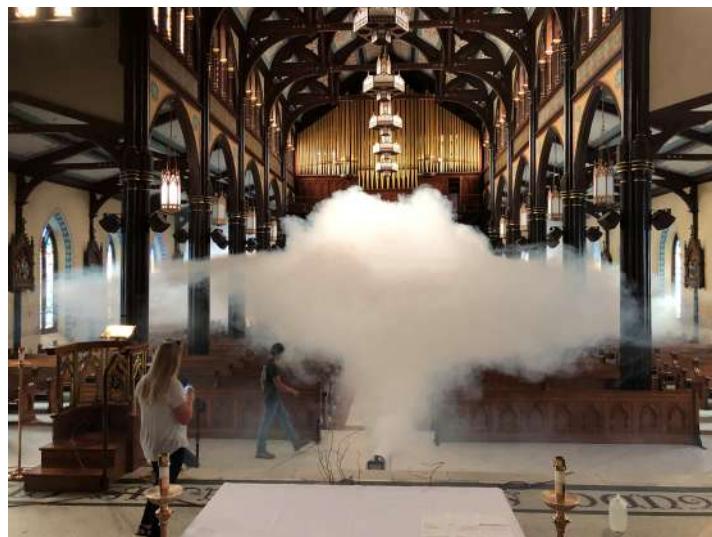
We didn't expect great results and yet we also didn't think it was wise to tell the Archdiocese of Galveston-Houston that the Church leaked without also providing a detailed account of where it was in fact leaking. The plan was for a two-step procedure to, first measure the level of air leakage by means of ASTM E779 whole building air leakage testing, then to follow the ASTM E1186 guidelines to determine where this 155 year old air barrier was indeed leaking. E779 testing revealed that if you combined all the air barrier leaks into a single opening, that opening would be a 24.31 square foot hole in the exterior envelope, just a little bigger than the front door on your house. Not that bad for a structure erected the same year Thomas Edison was born and anesthesia was first used for tooth extractions. We then took the obvious areas of leakage out of the test by taping over openings at the decorative exterior doors and the crawl space access hatches; this reduced the air leakage by a respectable two-thirds. Now, we needed to determine where the not so obvious areas of air leakage were located by following the E1186 procedures of using theatrical smoke and infrared image testing. Infrared image testing confirmed the areas we had suspected were allowing in outside air, but

it was the theatrical smoke that filled up St. Mary's from the Sacristy to the uppermost reaches of the Spires above the Narthex that revealed the hidden openings we were looking for.
