# Zero/Six

BEYOND THE EXTERIOR

June 2018

# LESSONS LEARNED AT RCI: PONDING INSTABILITY

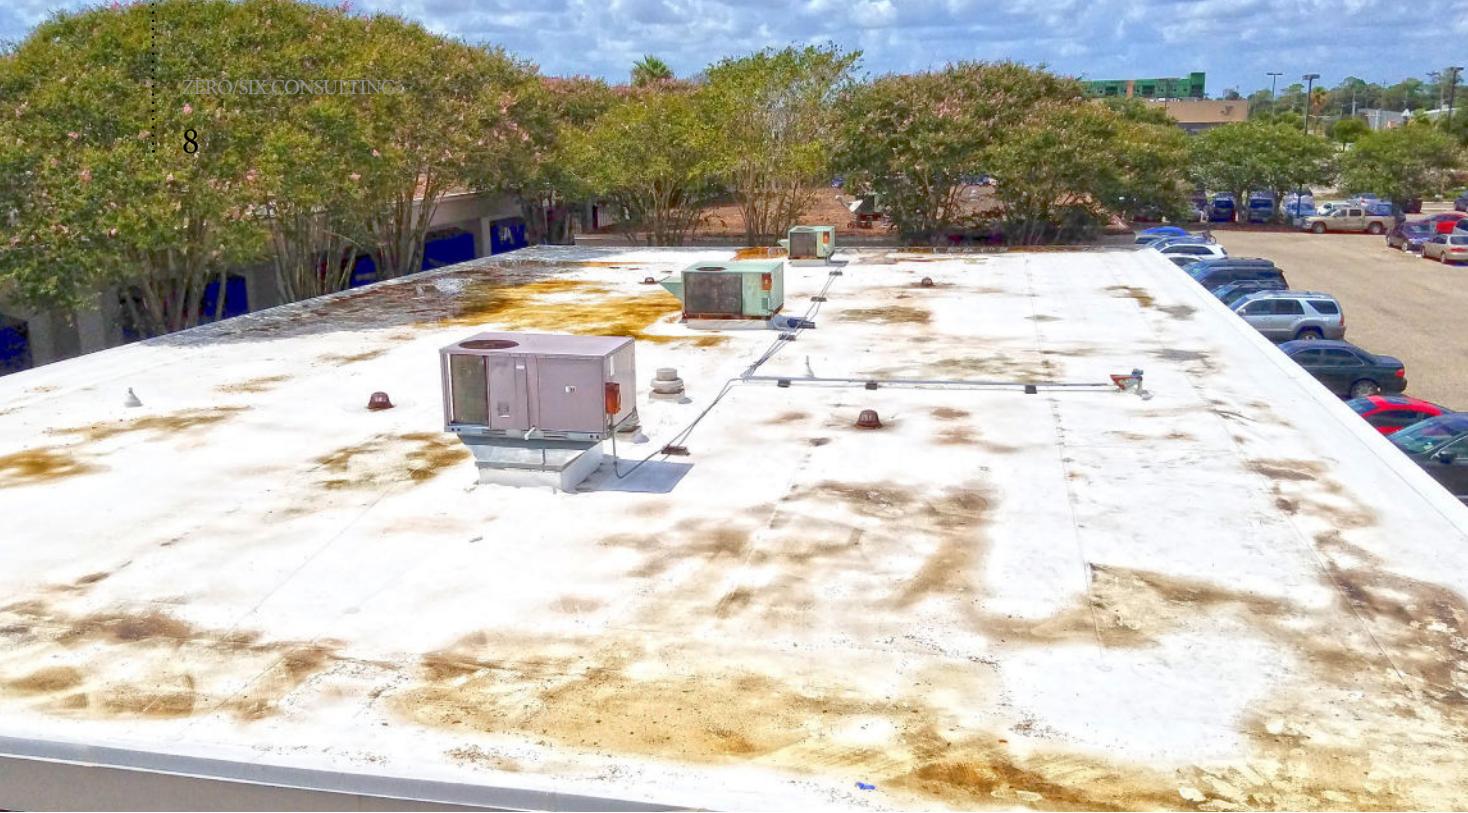
Photo Info : Lack of adequate slope (minimum  $\frac{1}{4}$ " per foot) causing ponding which destroys the membrane

The most important factor in preventing ponding on the roof is providing adequate slope to quickly and efficiently get water to the primary and overflow drainage. The newer building codes require one quarter inch per foot of slope and define those areas without adequate slope as "susceptible bays". Susceptible bays include areas where water is impounded - when the secondary drainage system is functional while the primary drainage system is blocked.

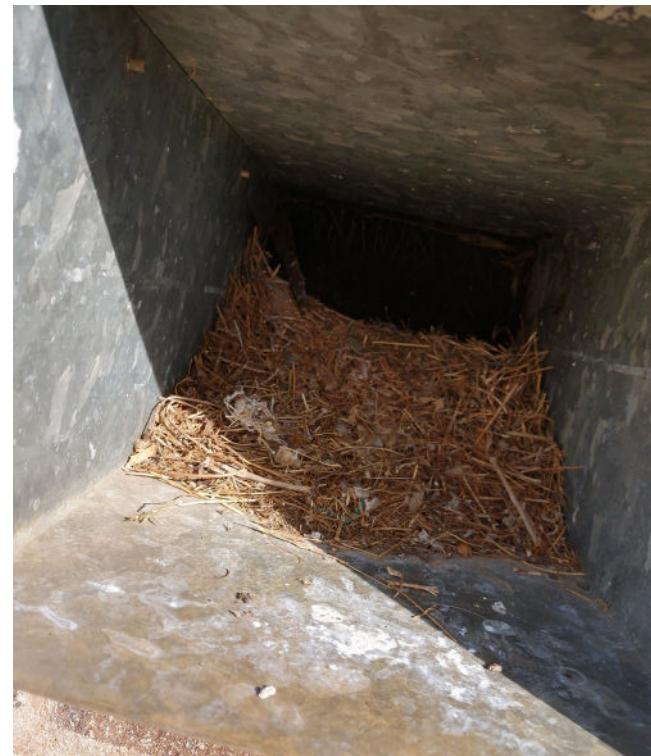
Photo Info : Scupper roofed over creating a birds nest

If cost is a consideration, scuppers are preferred versus overflow drains due to an increase in plumbing costs to discharge the overflow to an end point separate from the primary system. Section 1108 of the International Plumbing Code (IPC) also requires all overflow to be discharged to a location above grade that would be observed by building occupants or maintenance personnel. This is to alert all parties the primary system has backed up or become clogged, and the overflow drain now has to manage the water. With larger areas and bigger drains, it is a common mistake to create a sump for both drains with a hydraulic head that ends up being higher than the overflow collar. This arrangement can cause the overflow to activate during regular rain events without the primary drains being backed up creating staining on the walls. This also defeats the purpose of the visible discharge for the secondary drainage system because it's now unclear if it's activated due to the sump design or a primary system backup.

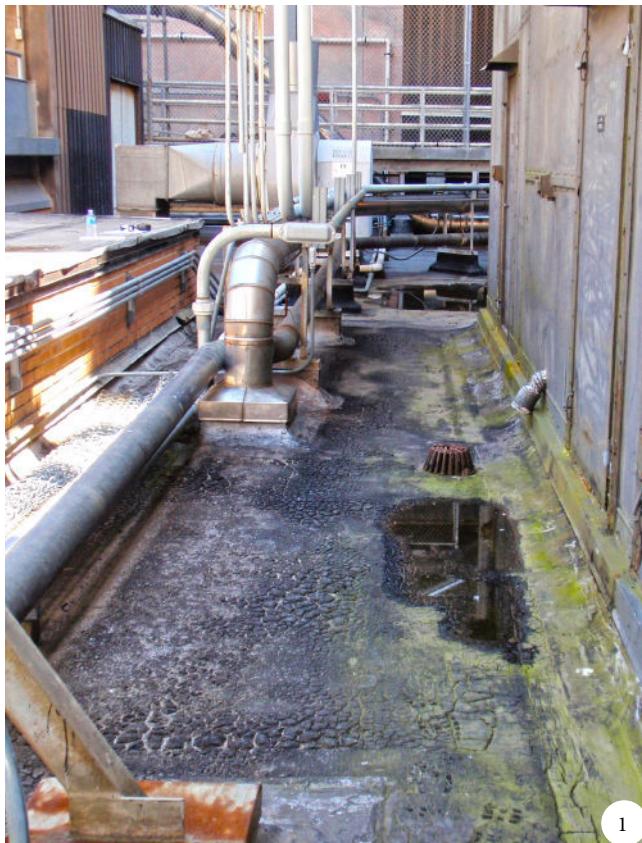
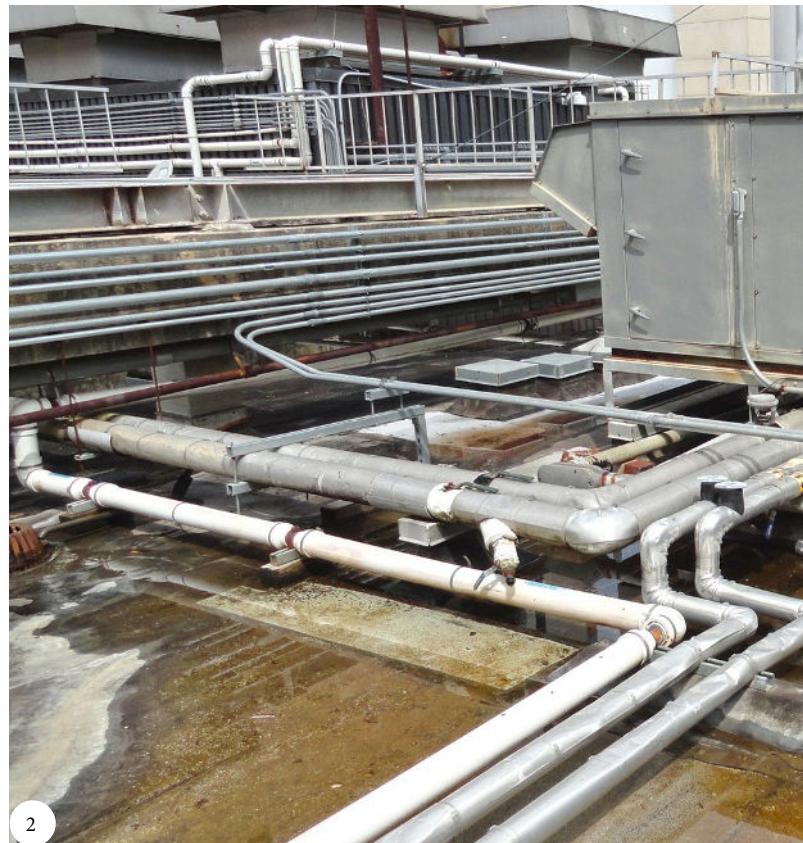
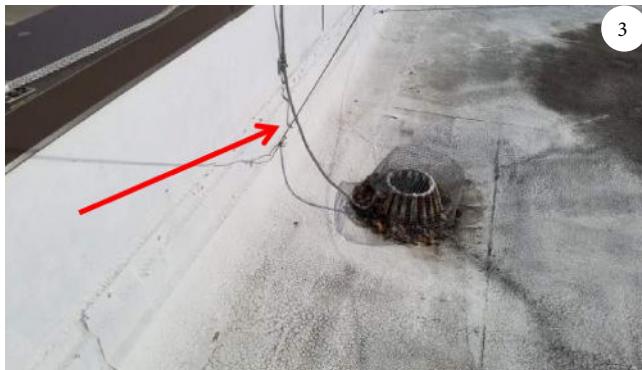
1. Photo Info : Lack of adequate slope (minimum  $\frac{1}{4}$ " per foot) causing ponding which destroys the membrane
2. Photo Info : Areas without  $\frac{1}{4}$ " per foot slope causing ponding
3. Photo Info : Overflow scupper has been roofed over
4. Photo Info : Lack of adequate slope (minimum  $\frac{1}{4}$ " per foot) causing ponding which destroys the membrane

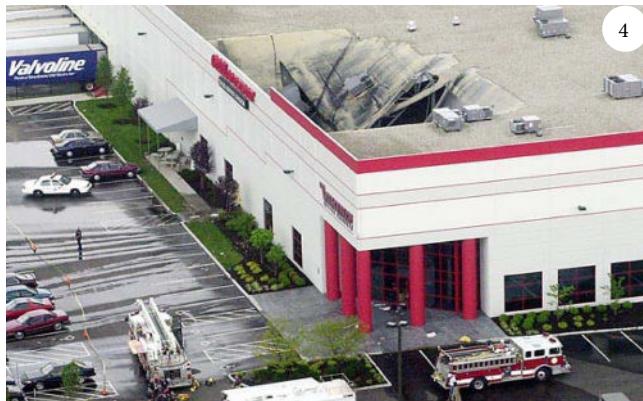
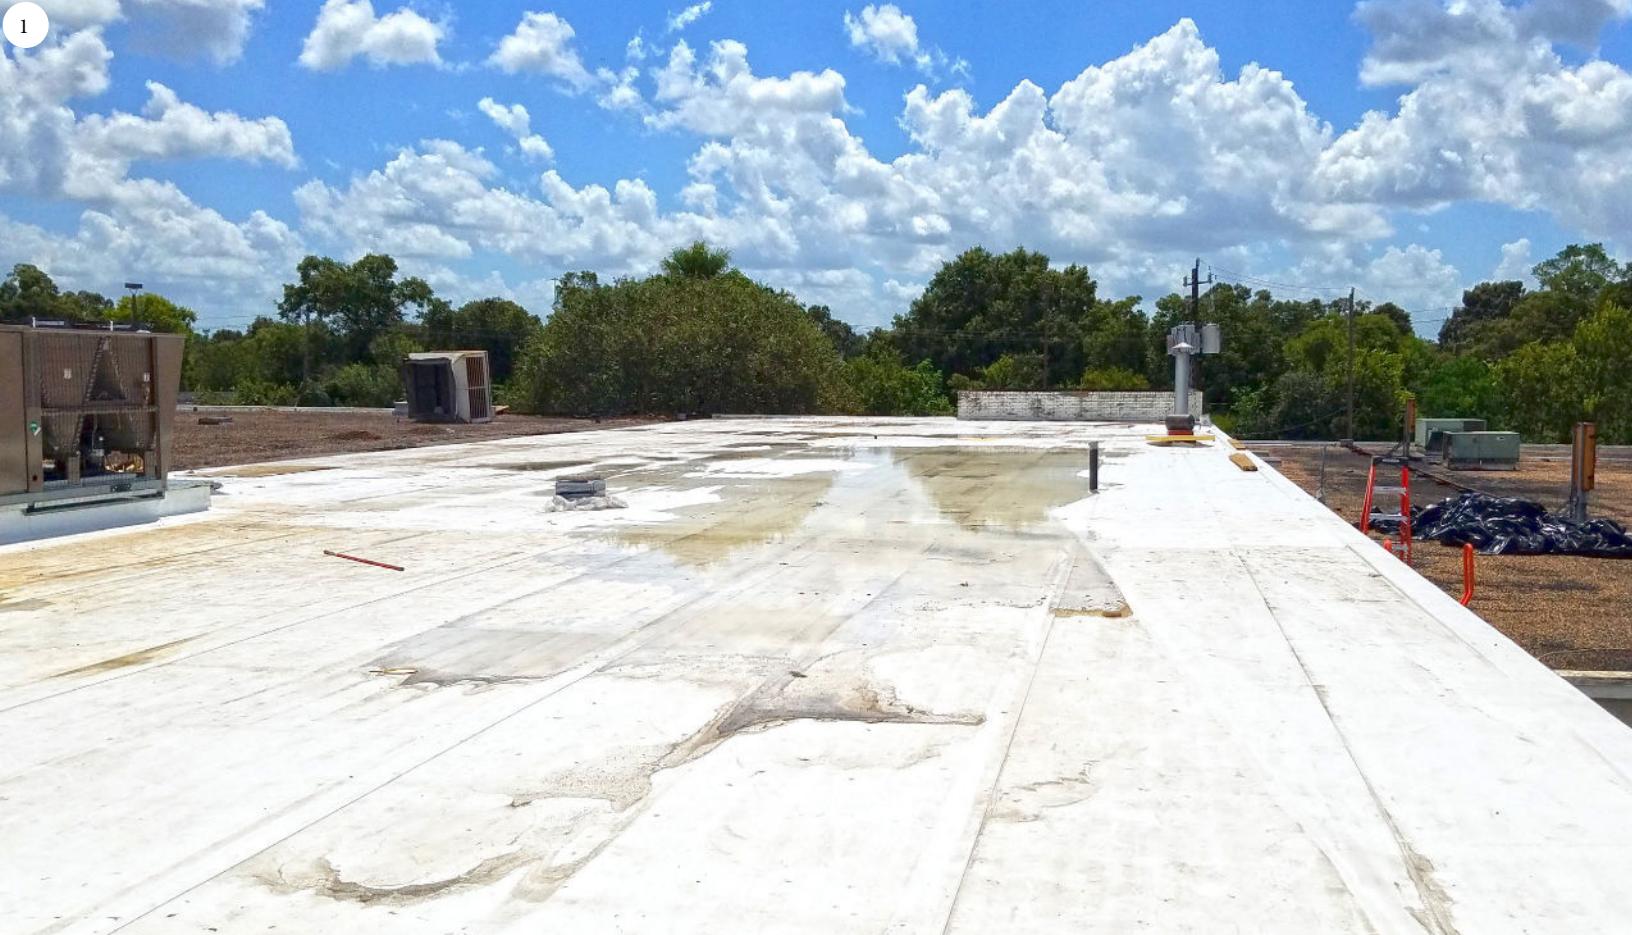
1. Photo Info : Lack of adequate slope (minimum  $\frac{1}{4}$ " per foot) causing ponding which destroys the membrane

2. Photo Info : Roof collapse - SJI Technical Digest 3

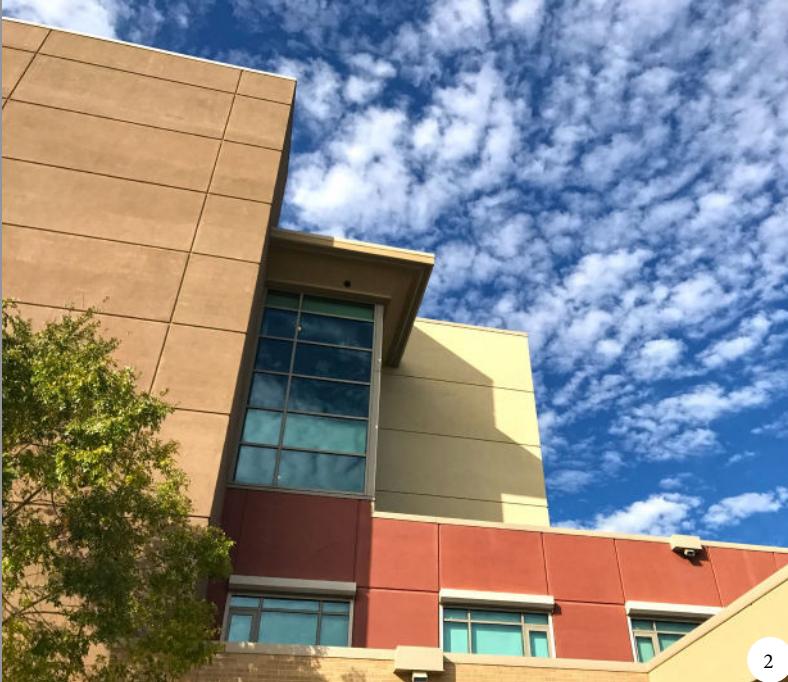
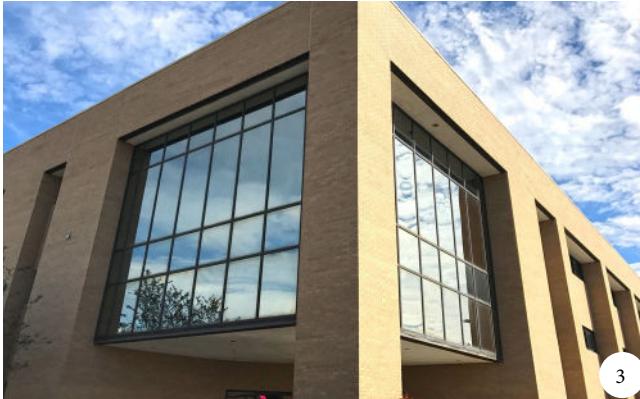
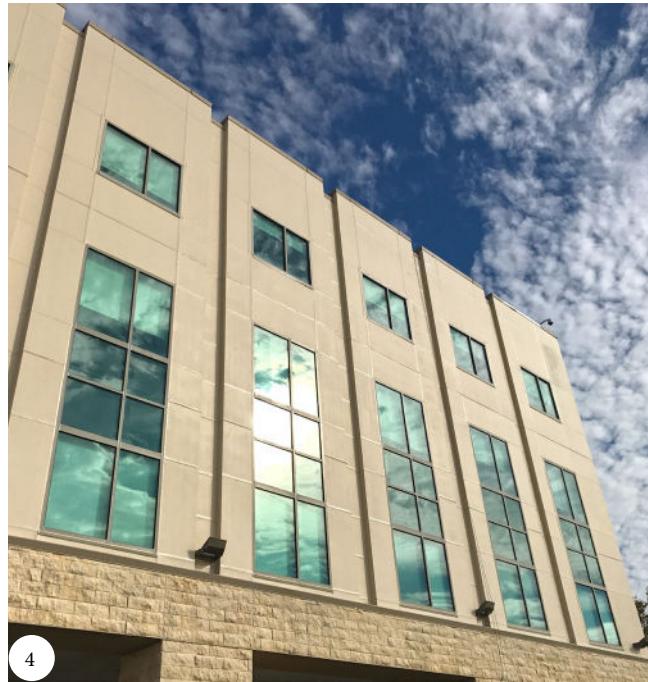
1. Photo Info : Trinity Tower, Beaumont Campus
2. Photo Info : Trinity Tower, Beaumont Campus
3. Photo Info : 810 Medical Office Building, Beaumont Campus
4. Photo Info : Trinity Tower, Beaumont Campus
5. Photo Info : 3570 Southeast Texas Medical Associates, L.L.P Building
