# Zero/Six

BEYOND THE EXTERIOR

February 2017

## LESSONS LEARNED IN THE FIELD: “THE WASHBOARD EFFECT” OF TORCHED APPLIED ROOFING MEMBRANES

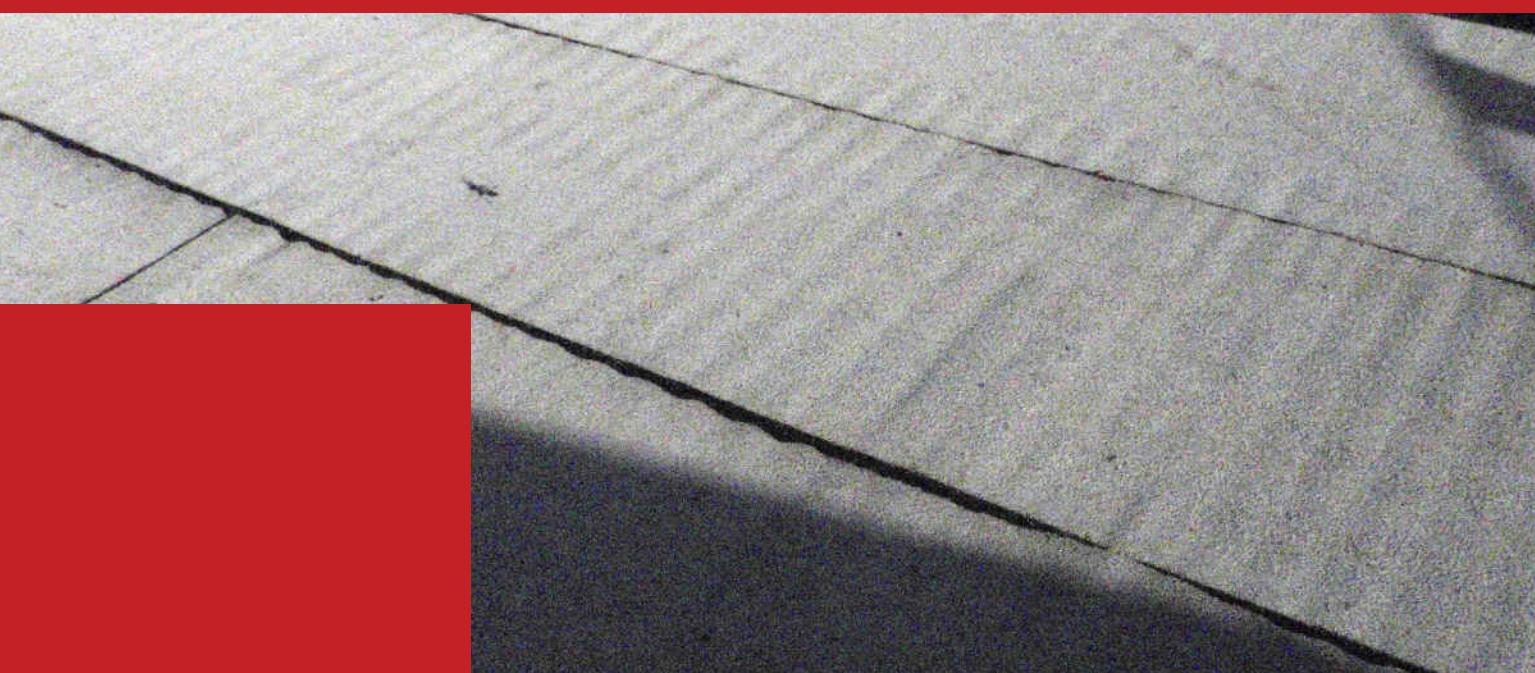
Figure 1: Washboarding observed on a Torch Applied Roof Membrane.

Recently, consultants and roof observers alike have observed an anomaly with torch applied modified asphalt membranes and hot mop applications that is being termed “the washboard effect”

**(Figure 1).** The term originated through observing ridge patterns seen at certain hours of the day. The ridge patterns are more visually prominent when the angle of the sun casts a shadow observable between each protrusion. The ridge patterns can be in localized areas, or in severe cases, throughout the entire torch-applied built-up membrane installation.

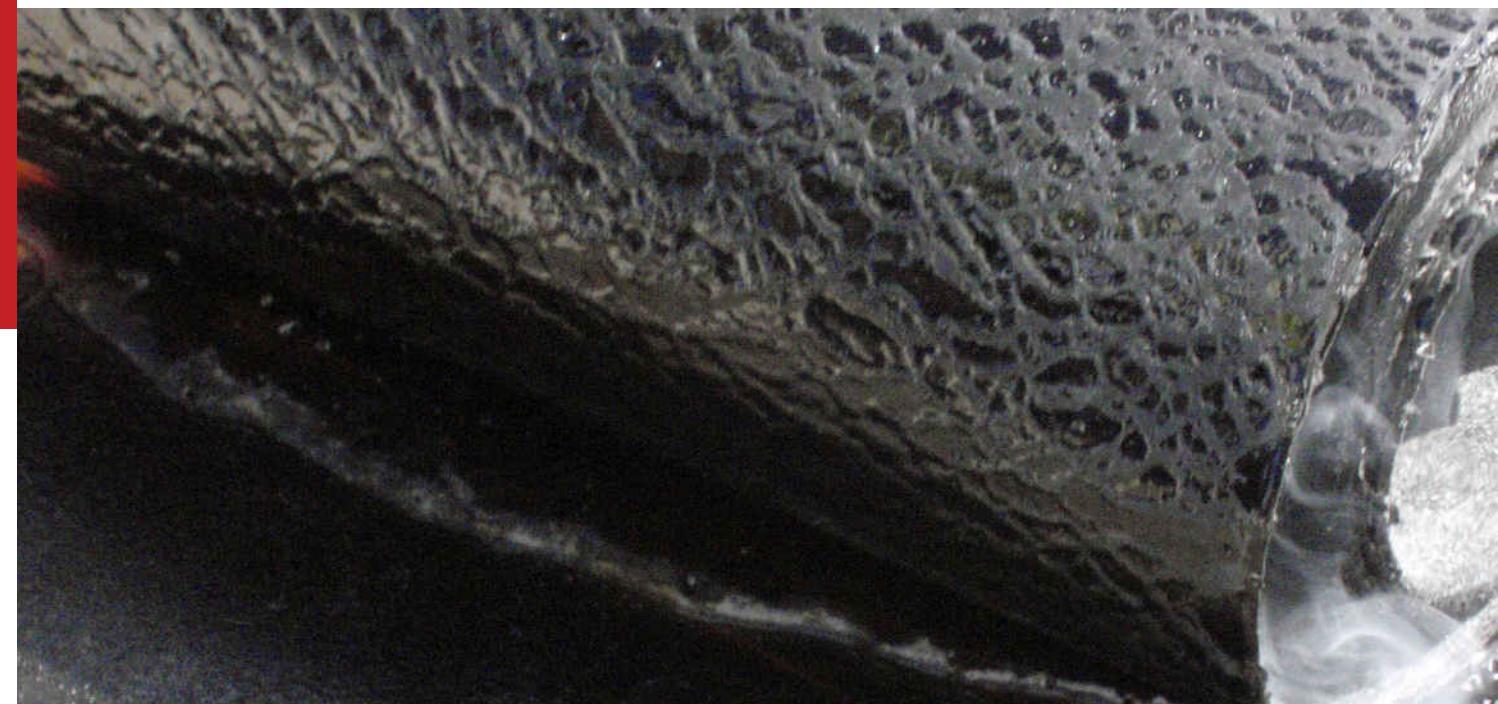
Figure 2: Modified Asphalt pool at Roll Base during Application.

The torch flame is directed to a localized area at the face of the membrane roll while stationary, the face of the roll begins to soften, and with excess heat will liquefy, creating a pool of modified asphalt in front of the roll (**Figure 2**). The membrane roll is then pulled or rolled forward over the pool of modified asphalt that is cooling quickly upon contact with the roof substrate thus creating a small hump or ridge beneath the membrane. When this application method is repeated, you begin to observe a ridge pattern anomaly in the roof membrane.

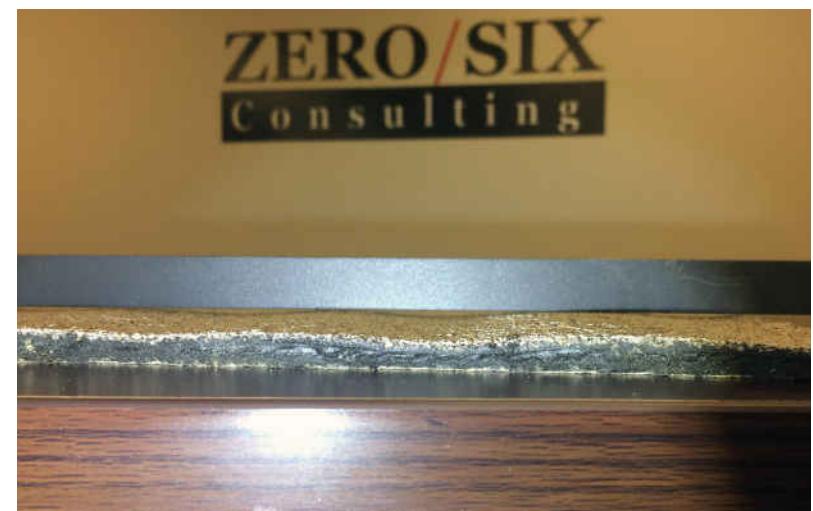
Figure 3: Uneven Distribution of Modified Asphalt beneath Membrane.

Examination of a roof sample containing the ridge pattern anomaly revealed small humps in the membrane which are apparent with a straight object positioned across the ridges. The modified asphalt bond is unevenly distributed beneath the membrane due to improper torch application and excess heat (Figure 3). The point of application temperature the membrane is exposed to during installation is critical.

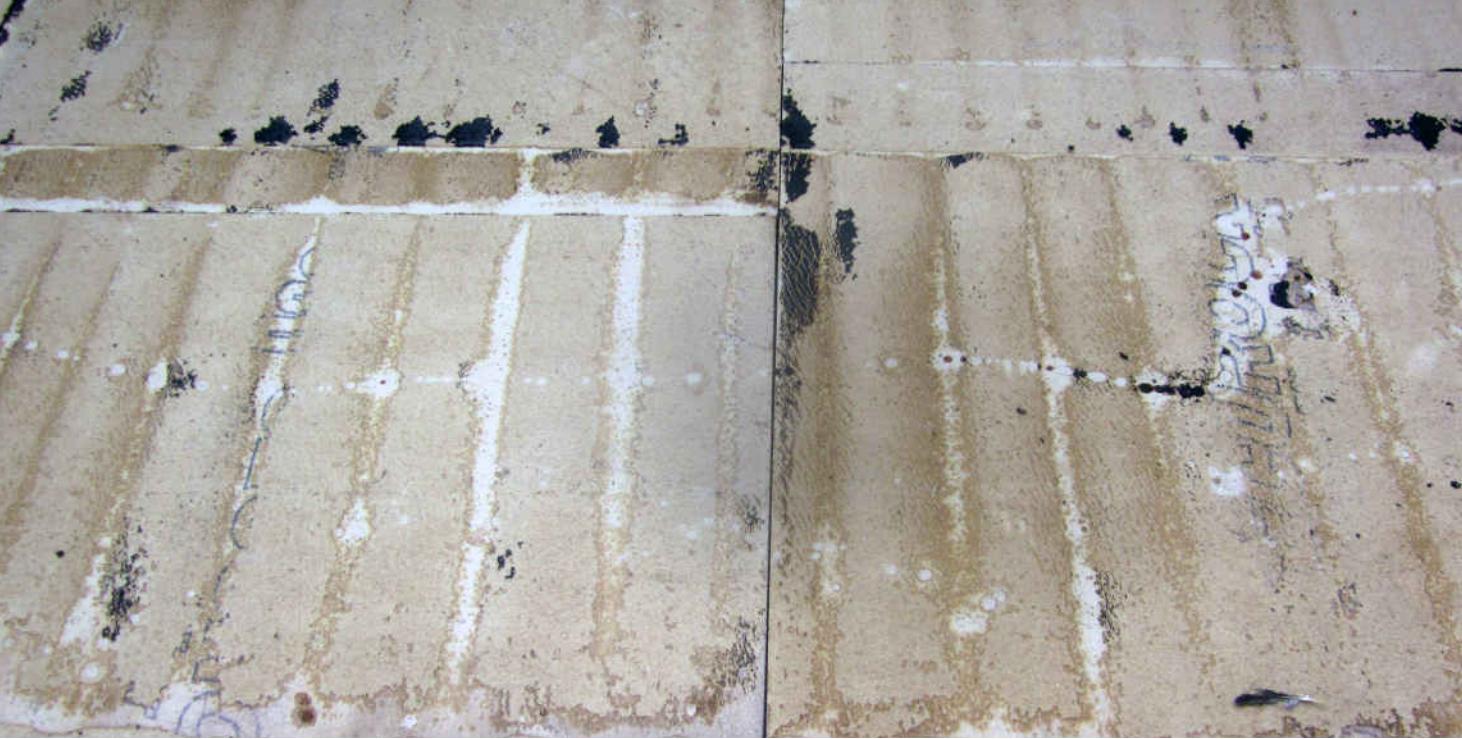
Figure 4: Uneven Distribution of Heat Apparent during Forensic Analysis.

An experienced torch applicator applies a consistent "L" shaped distribution of heat to the face of the roll and partially up the seam. This is done in conjunction with smoothly pulling or pushing the roll as typically specified per the manufacturer's instruction. During a forensic evaluation of the anomaly, evidence of uneven distribution of heat at the point of application is apparent from the burn pattern on the gypsum cover board layer after membrane removal (Figure 4).

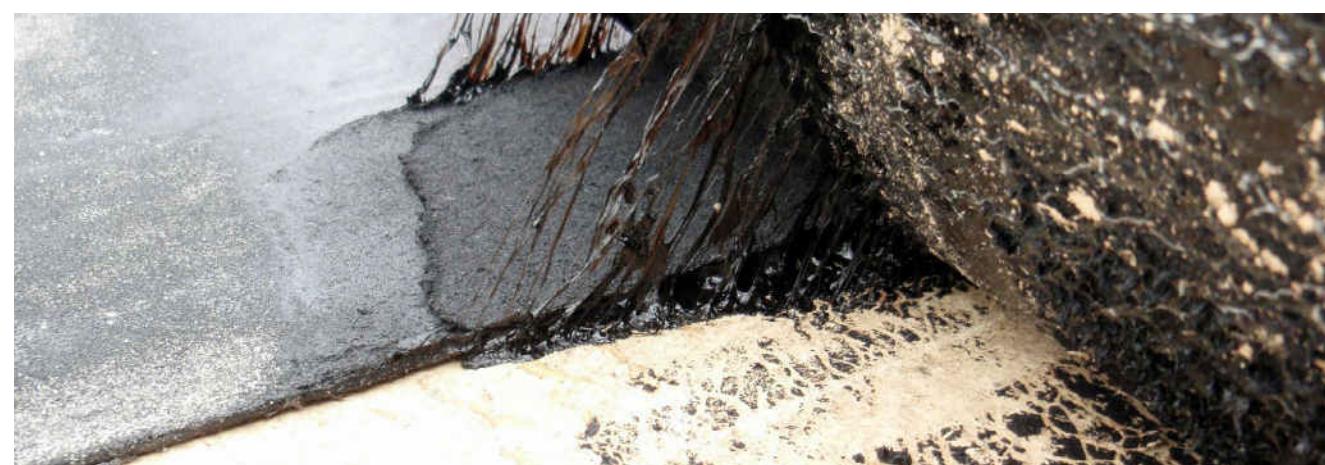
Figure 5: During proper heat application of torch applied membrane, the roll can be rolled back and "stringers" of modified asphalt can be observed. This is an indicator of adequate heat at the point of application.

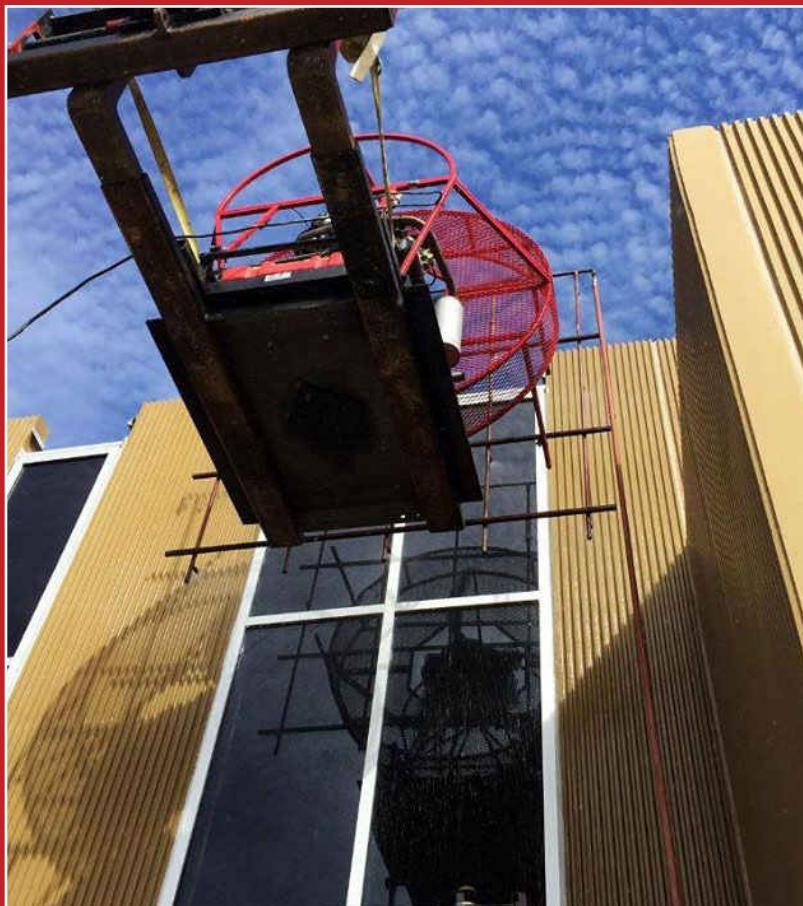
### ▲ Performance Testing with Z6 Commissioning

A little mobile, wind-driven rain performance testing in the sunshine from our dynamic fan "Alicia" for the City of Schertz Recreational Center! #blownaway

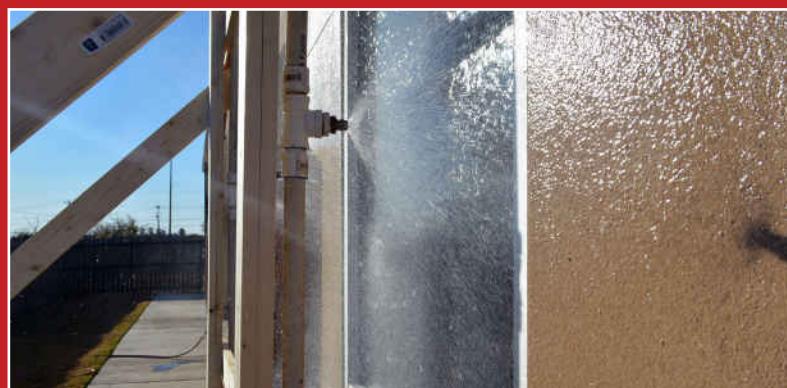
### ISO Accredited Testing ▲

The Z6 Commissioning team performing #ISOaccredited chamber testing for WHCI International in the Rio Grande Valley #ANAB

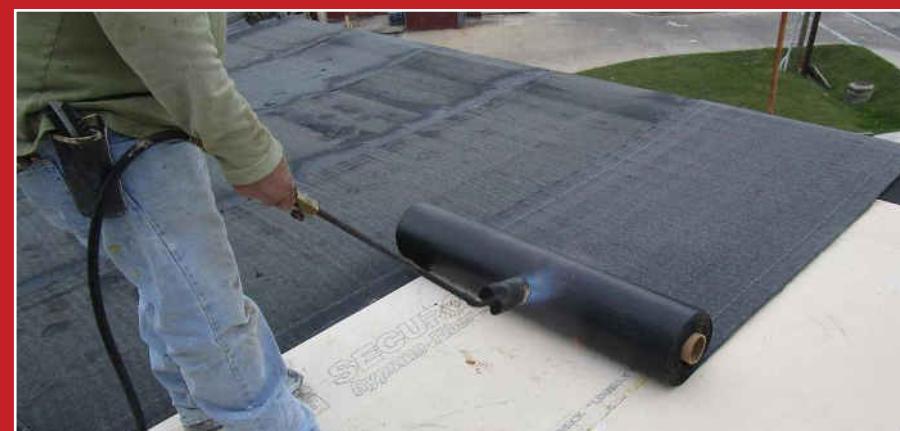
### ◀ Facility Asset Management

SBS modified bitumen base ply being torched to cover board at the City of Houston HFD Fire Station.

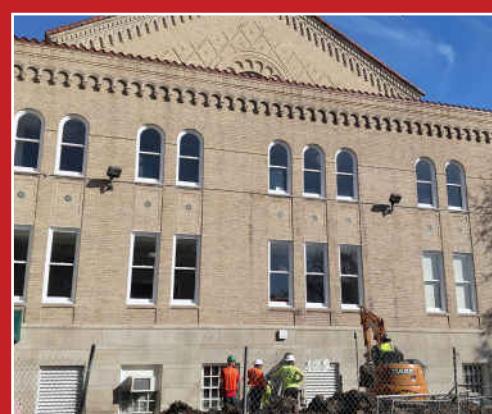
### ▲ South Main Baptist Church Below Grade Waterproofing

Personnel excavating along basement wall 11' deep for the installation of below grade waterproofing along the west elevation of South Main Baptist Church.

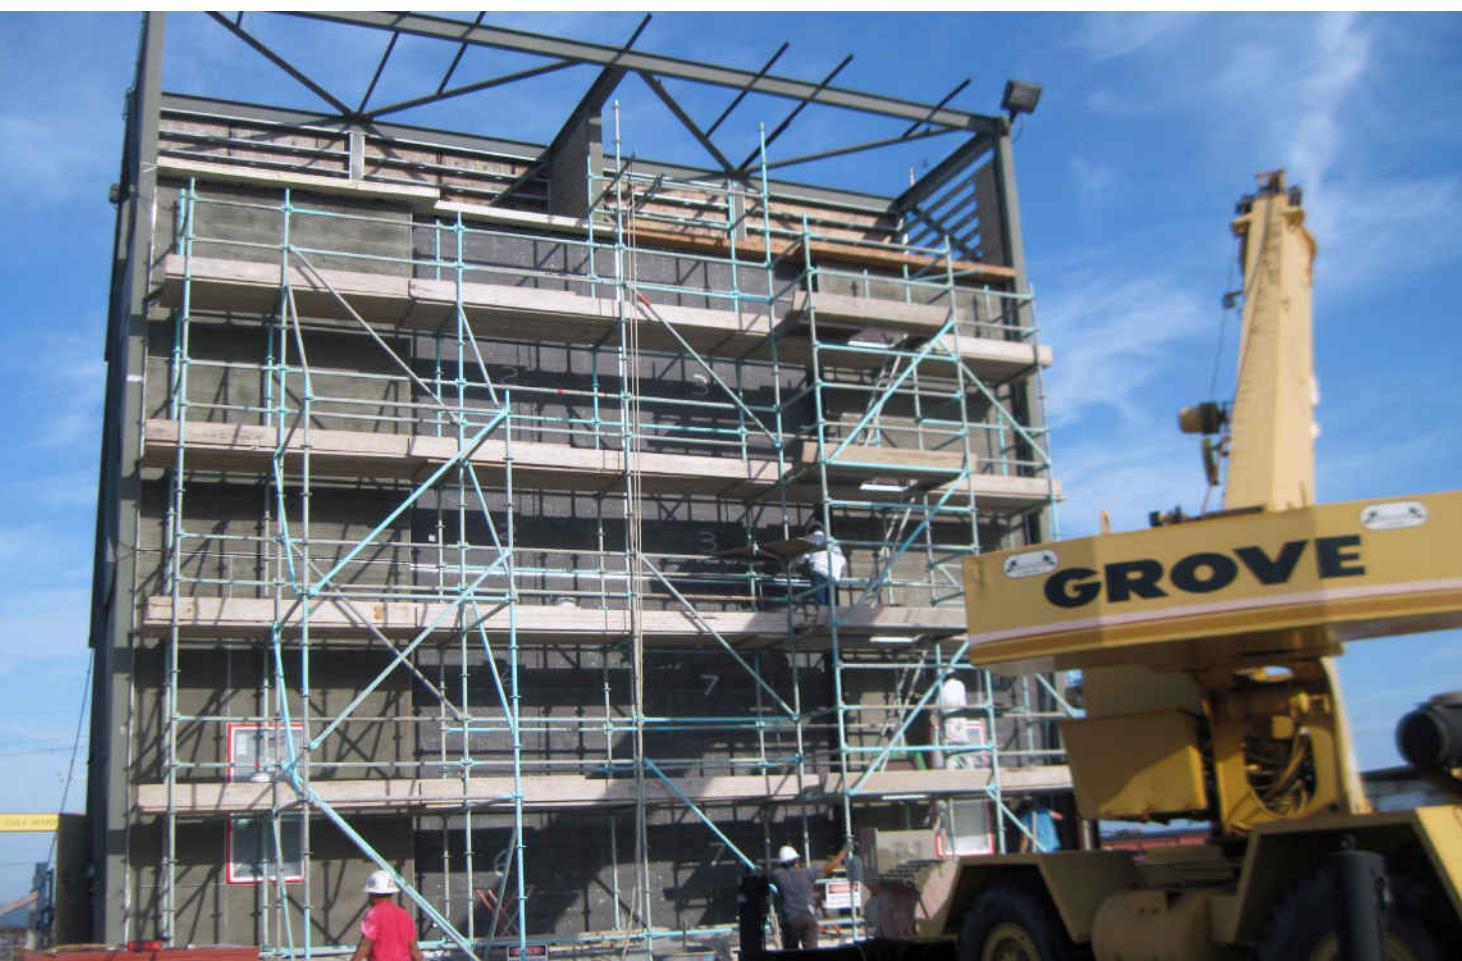
Photo Info : The Z6 Commissioning (Z6) Stucco Mock-up at the Z6 Accredited Laboratory in Galveston, Texas.

Zero/Six is proud to work with some of the best companies in the AEC industry to ensure optimal building performance for our clients. This month, we're featuring long-time strategic partner Houston Lath and Plaster. Together with Z6 Commissioning, we're conducting testing on a 40' wide x 32' tall stucco mock-up that is garnering national attention and will likely impact future codes related to stucco installations.

because it's the way we've always done it. On the other hand, many in the AEC industry love to have it separated to allow for movement of the joint during the initial stucco cure, with 60% of stucco movement occurring during the initial cure. So we, together with some sponsors who are committed to our industry, have assembled a 1500 square foot structural mock-up. We have identical panels, one has continuous lath and the opposite hand has cut lath.

All control joints are wired to the lath, as they should be. This allows them to flex with the lath and stucco during cure and thermal variation because they are not pinned to the structure.

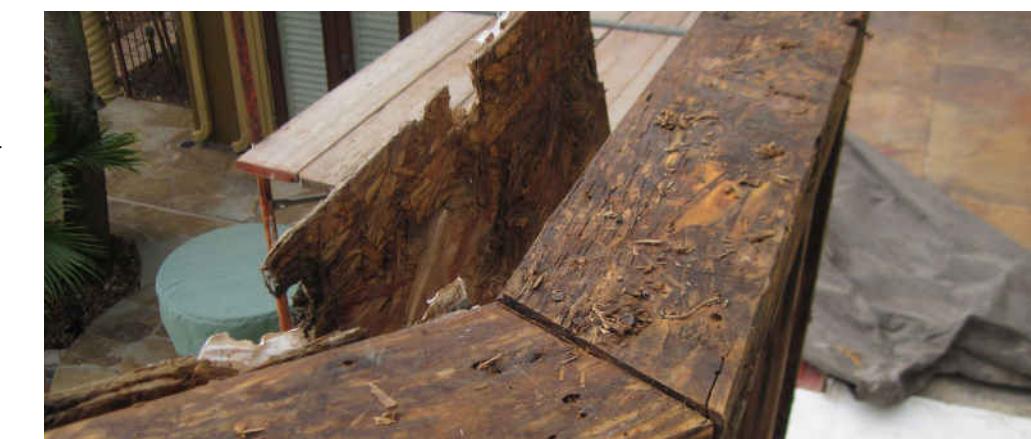
Photo Info : Water Damaged Column.

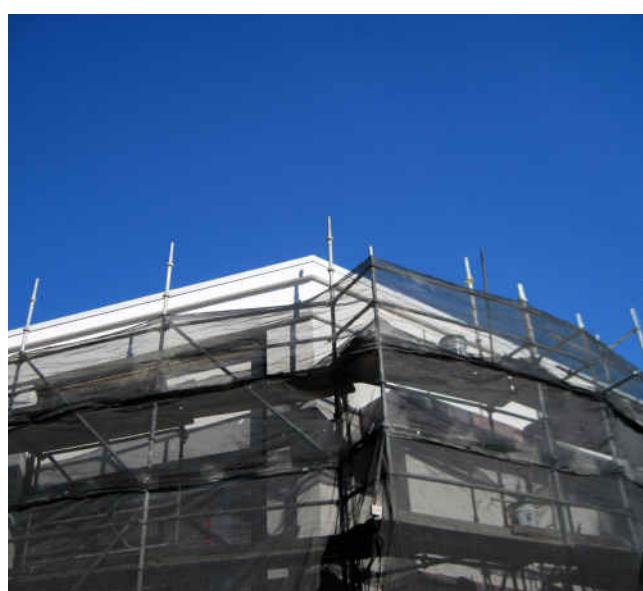
Photo Info : Tommy Bahamas Exterior Insulation and Finish System (EIFS) Underway.
